VILLAGE DESIGN GUIDELINES

VILLAGE PLANNING AREA, INCLUDING VILLAGES OF EAGLE & BYERS Upper Uwchlan Township, Chester County, Pennsylvania

**Prepared by
Richard Grubb & Associates, Inc.
The Brandywine Conservancy, Inc.**

Draft: June 21, 2024

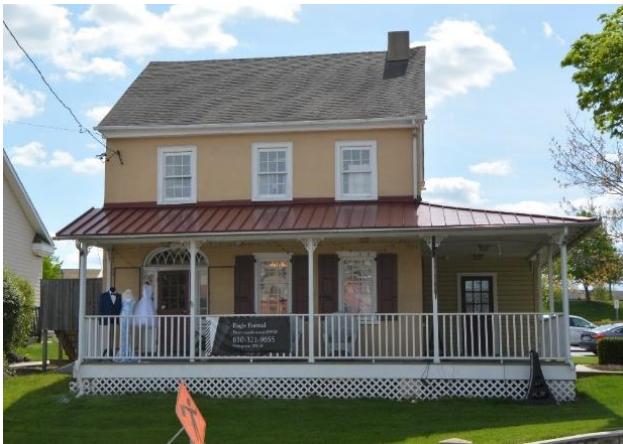
Beerbower/Pugh House, 350 Pottstown Pike

The Federal Style emerged after the American Revolution as a refinement of the Georgian style of the eighteenth century. An important example in Eagle is the Beerbower/Pugh House (Historic Resource #88, pictured above). This two-story house is an example of the Side Hall Plan; it retains its original fanlight with intersecting tracery and has an Italianate-style wrap-around porch (added later). Differences between Federal Style houses and their Georgian predecessors include increasingly flat walls, occasional use of curved elements, and increasing symmetry. Louvered shutters were also introduced during the Federal period.

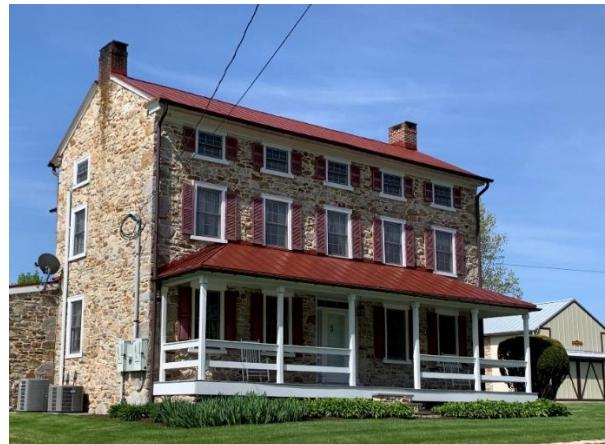
Conrad Keeley House, 395 Font Road

The Greek Revival style was introduced in the 1820s. The high-style Greek Revival style buildings replicate a classical Greek temple using front end gables, porches with thick entablatures, frieze band windows, and hipped roofs. These high-style Greek Revival residences are less prevalent in Southeast Pennsylvania. Here the more common type of Greek Revival style is usually a Federal style building with Greek Revival features. These houses often have a more traditional farmhouse appearance with frieze band windows on the upper floor, such as the Conrad Keeley House (Historic Resource #23, pictured above).

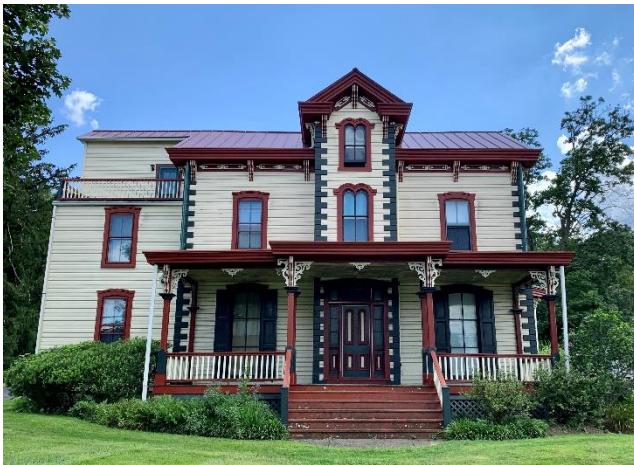
John Todd House, 210 Byers Road

The John Todd House in Byers (Historic Resource #65) is an important local example. The house has a two-and-a-half-story, three-bay main elevation facing the road. It features a gabled roof with overhanging eaves supported by brackets and a projecting center bay. The corners of the house use large wooden blocks that imitate stone corner blocks called “quoins.” (Wooden quoins are common on several buildings in Byers.) Other key features of the house include windows that are larger than those found in earlier architectural styles and a full-length front porch (“piazza”) with decorative brackets.

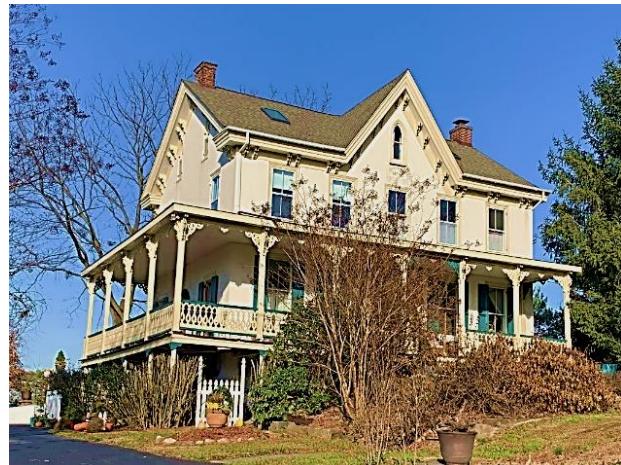
Robert Phipps House, 500 Park Road

The Robert Phipps House (Historic Resource #102, pictured above), is an example of the most common type of Gothic Revival houses in Chester County. It is a two-and-a-half story, three-bay building with a centered cross-gable. Pure Gothic Revival style houses have rather simple porches, often with light spandrel elements, but it is also common to see a Gothic Revival style house with a porch featuring heavy Italianate brackets.

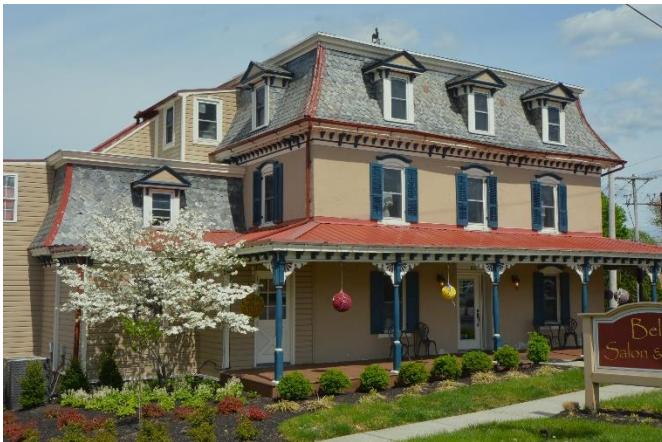
William Sheetz House, 102 Pottstown Pike

Second Empire style houses often added decorative ironwork called cresting at the top of the Mansard. The style was in many ways an elaboration of the Italianate style, as it used many Italianate characteristics: a heavy molded cornice supported by thick brackets, large windows, doors with thick molding profiles, symmetry, and a nearly flat outer wall surface with a wrap-around porch. The key example in Eagle is the William Sheetz House (Historic Resource #74, pictured above), at the northeast corner of Pottstown Pike and Byers Road.

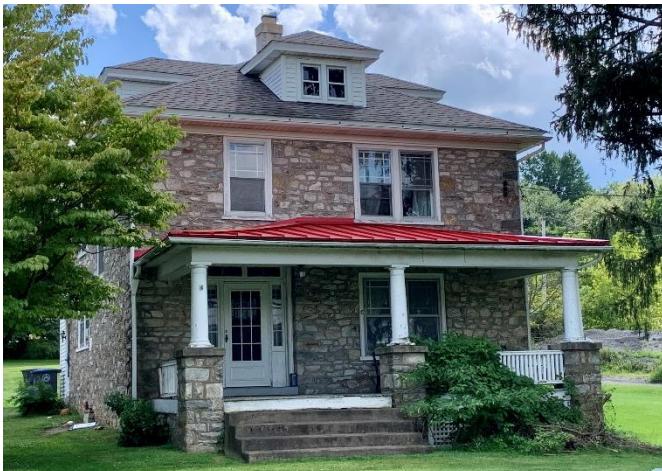
Woodland House, 204 Byers Road

The house at 204 Byers Road (Historic Resource #64, pictured above) is a Byers example. It has Prairie windows with the muntins offset from the center, paired windows in the west bay, and a typical hipped porch of the era with short columns standing on stone piers. American Foursquare houses usually feature four rooms on the two main floor levels, with one room opening into its two adjacent rooms rather than using a hallway to connect the rooms. Side entrances were often located between the first-floor level and the basement level, with interior stairs required at that entrance to enter the building. Although 204 Byers Road has stone walls, most Foursquare houses had wood cladding.

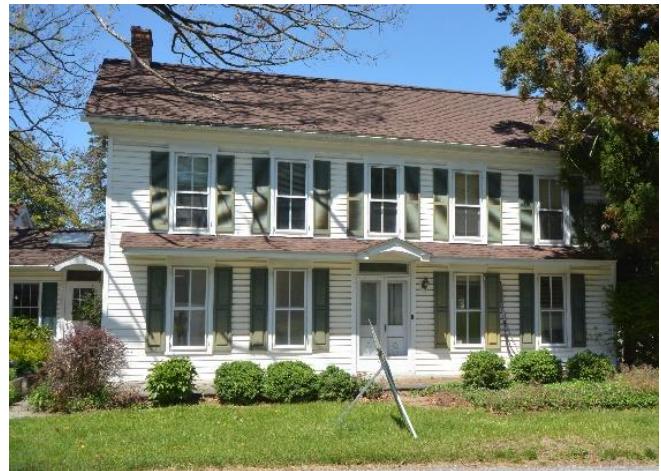
A. M. F. Stiteler House, 211 Byers Road (prior to late 2023 fire and demolition)

Note: The A. M. F. Stiteler House (Historic Resource #57, shown above [*Historic Resource Demolished]) was heavily damaged by fire in late 2023, resulting in its demolition.

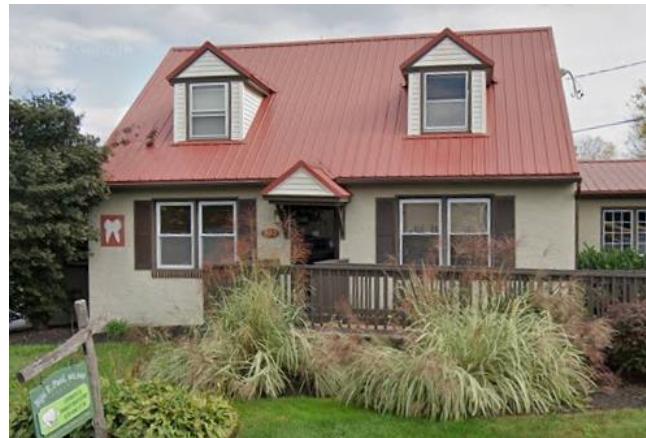
The house at 207 Park Road (Historic Resource #165, pictured above) is a typical example of the type.

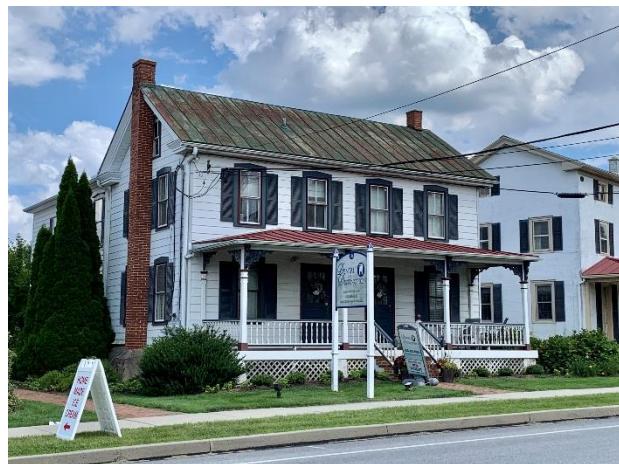
Gabled roofs are the most common roof type in the VPA (Isaac D. Frame House, 124 Pottstown Pike, Eagle).

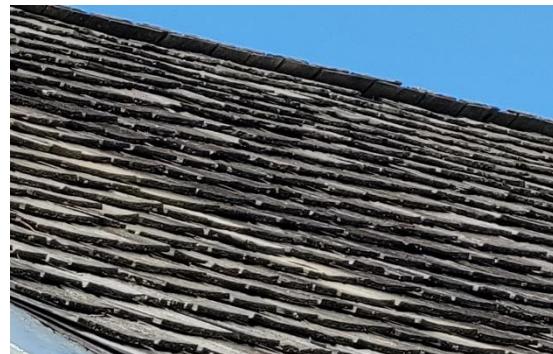
Few wood shingle roofs remain in the VPA.

- f. **Wood Shingles:** Though few in number in the VPA, wood shingles should be replaced in-kind. Replacing asphalt roofs with wood

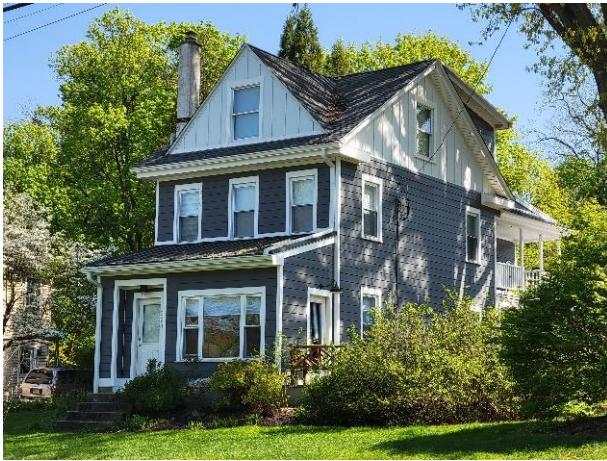
Cross-gabled roofs, as pictured, are not common on historic buildings within the VPA. Note the shed dormer at the rear of the building. (Joseph Grow House, 230 Byers Road).

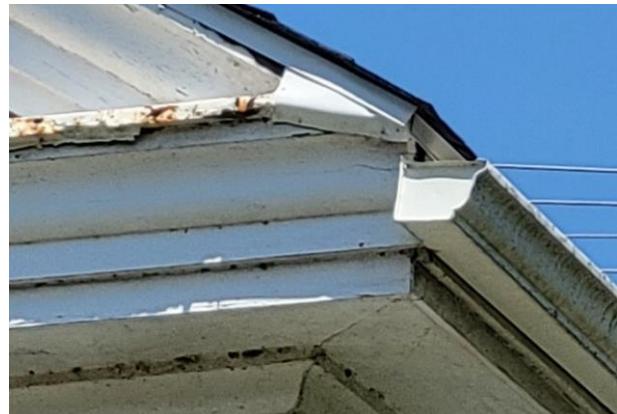
Contemporary K-style (molding shaped) gutter was installed on these buildings.

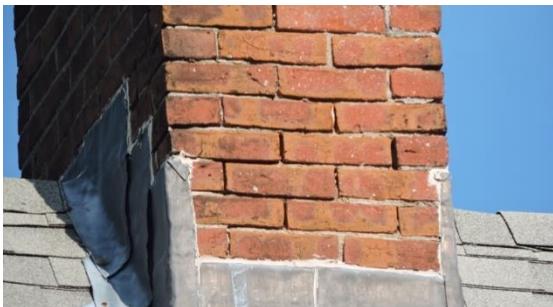
Open mortar joints may allow water to penetrate and deteriorate the brickwork.

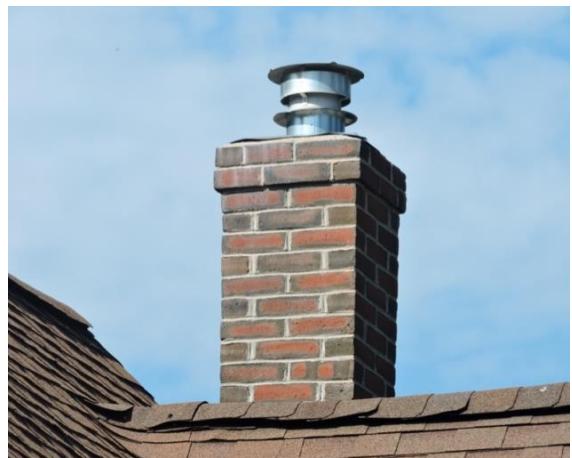
A variety of metal cap types have been installed on chimneys, not historic but acceptable for fire safety. This metal vent system is part of a rebuilt chimney with brick reasonably similar to the appearance of historic brick.

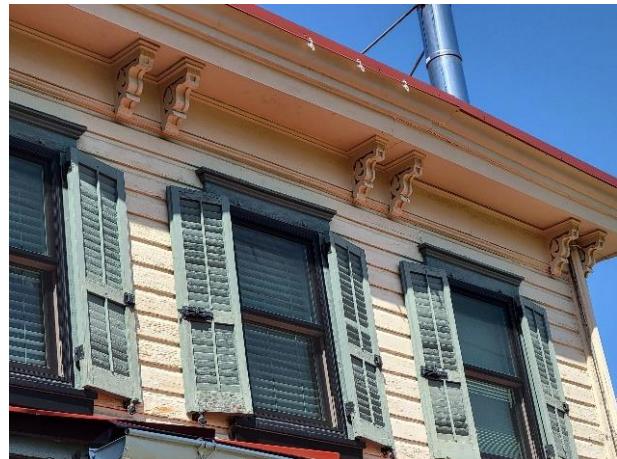
Many types of wood elements are found throughout the VPA. This house has wooden eaves, brackets, siding, and shutters.

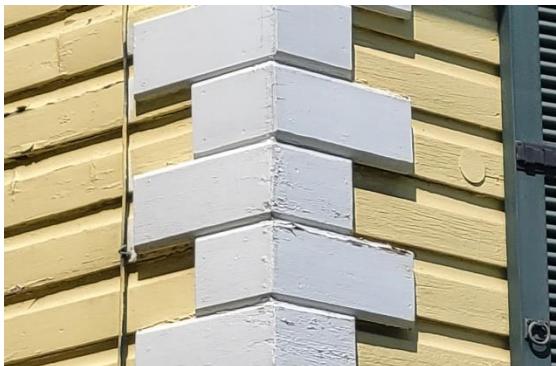
Decorative wood quoins at corners are commonly found in Byers. This Italianate feature should be maintained as much as possible, and if elements of the original wood must be replaced, it is recommended to have replacement wood of the same shape and character.

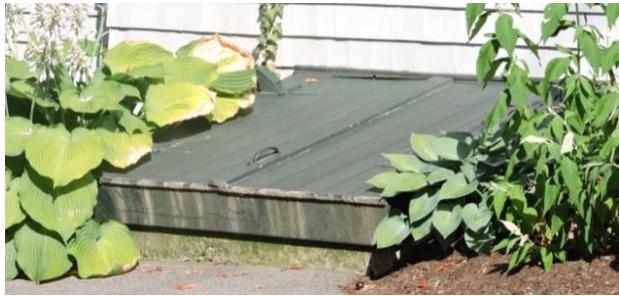
Wood basement door.

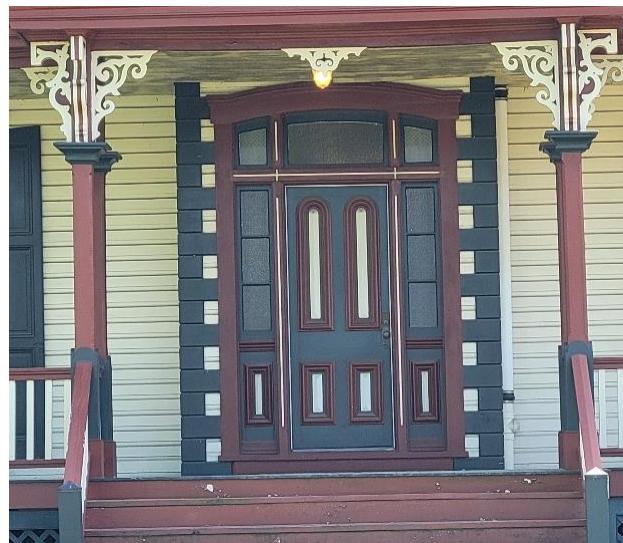
Historic wood doorway with solid paneled Italianate style door on the Todd House, displaying divided sidelights, transom, wood trim and wooden quoins.

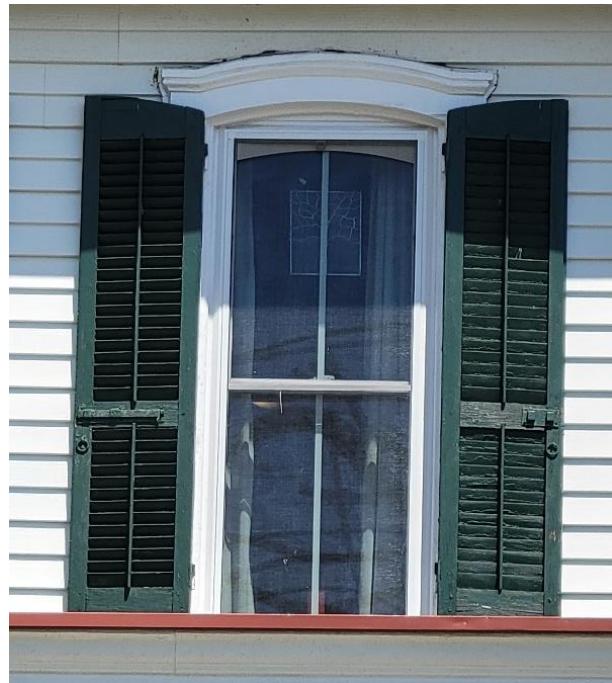
Typical Italianate style, two-over-two sash window with arched head, authentic flanking shutters shaped to fit, and decorative cap trim and surround.

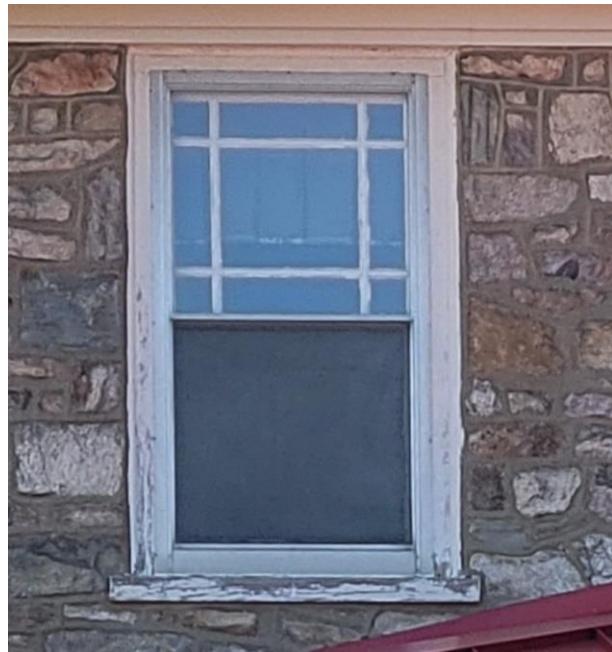
Period windows such as this Prairie window in Byers contribute to the historic appearance of many historic houses. These windows should be retained as much as possible, particularly on the main elevation of the house (Woodland House).

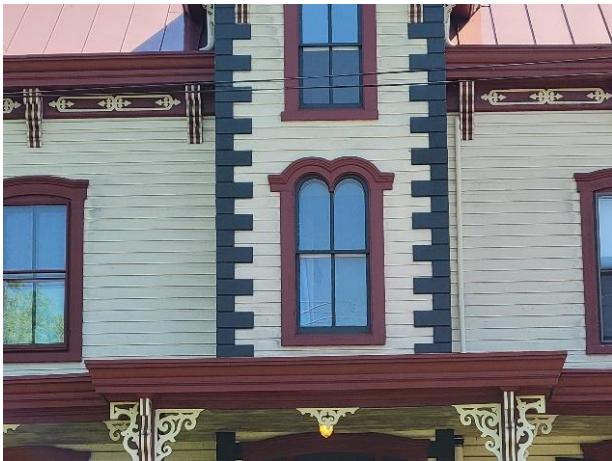
Some buildings within the VPA appear to retain authentic historic windows and detailing dating to the period of their construction (Todd House, Byers Station Historic District

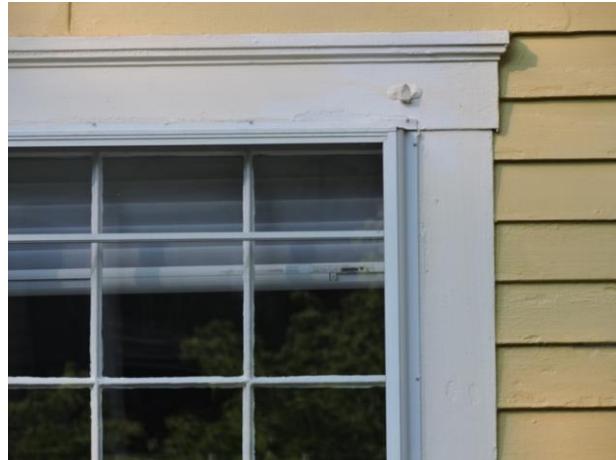
This exterior metal storm window is discretely mounted on the historic window frame, matching its size, and is barely visible.

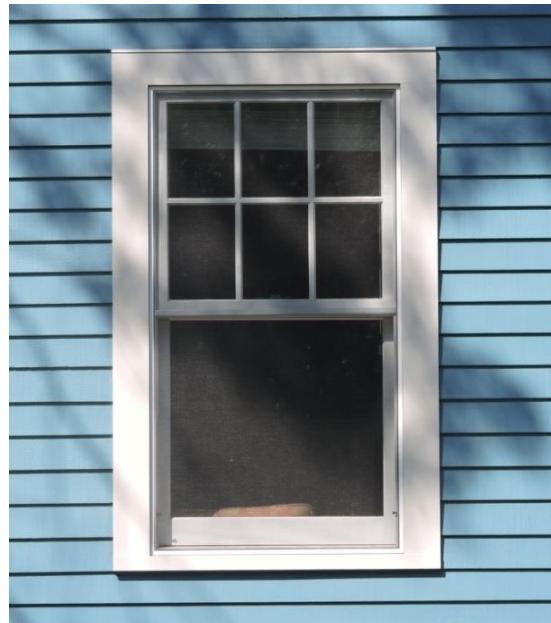
Replacement windows should match the full size of the historic window opening.

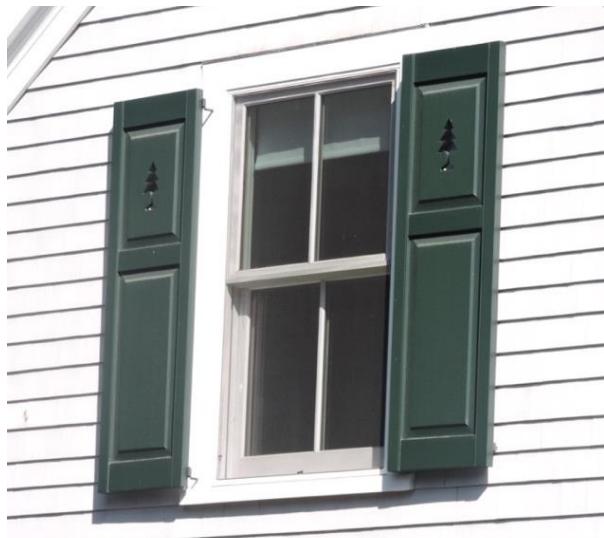
Authentic wood reproduction windows are preferred, although manufactured wood windows with finished metal cladding or factory-coatings may be appropriate.

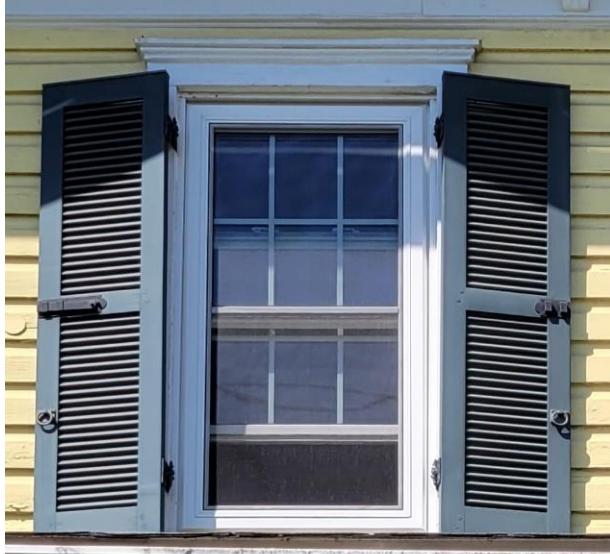
Shutters should match the height and width of the window opening and be operable or at least appear to be operable.

- c. **Shutter Size and Configuration:** New shutters should match the height and width of the window opening where they are being installed. Shutters should be mounted to be operational or appear to be operational.
- d. **Shutter Materials and Design:** Shutters should be of wood construction, but high-end composites closely simulating wood may be appropriate, and either one should be protected with a painted coating. Shutter form and design should be similar to what existed historically, if known. Panels on historic shutters relate to the sizes of panels on the front door.

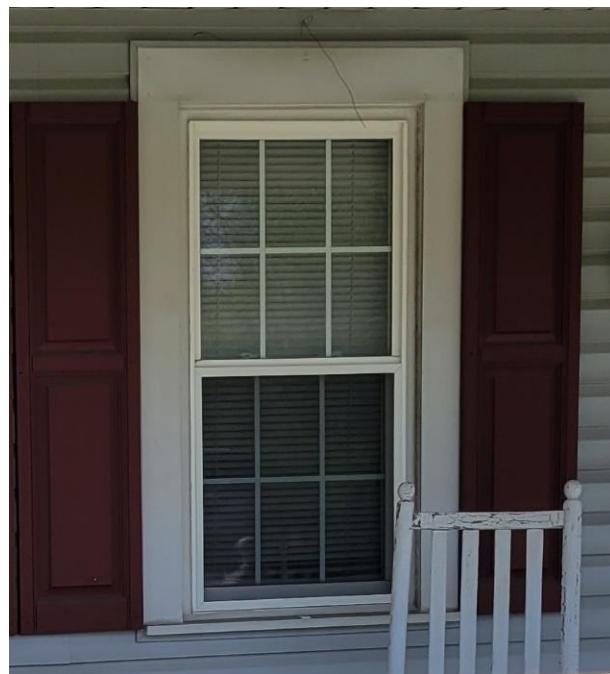
Faux shutters are not recommended.

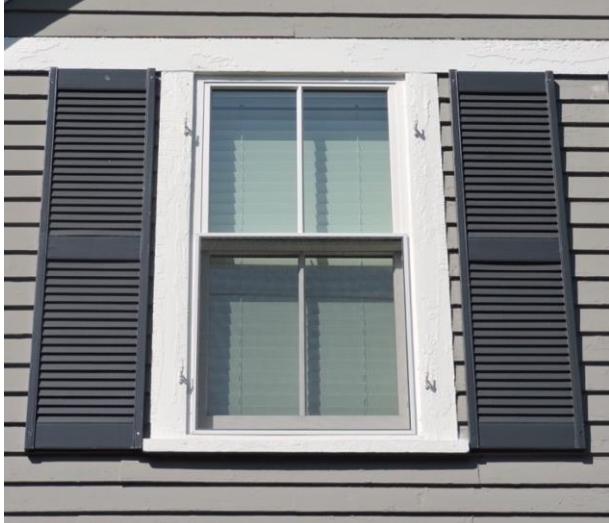
In this example, despite the presence of authentic shutter hardware on the frame, shutters are mounted flat on the walls adjacent to the window, which could have been avoided.

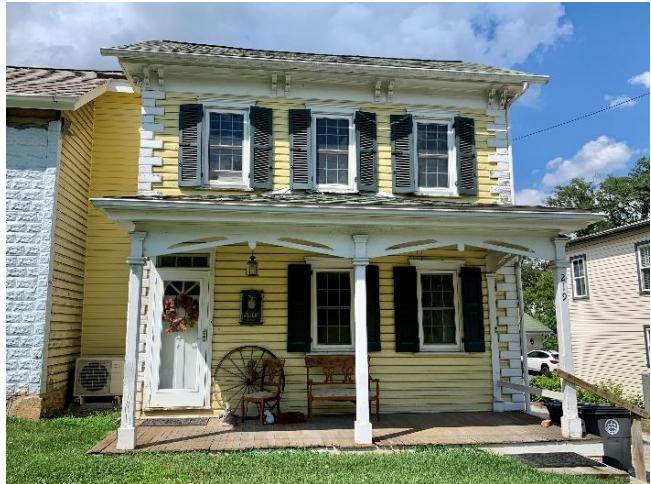
This fine porch is a major expressive detail of the Italianate style (Emeretta Green House, 219 Byers Road).

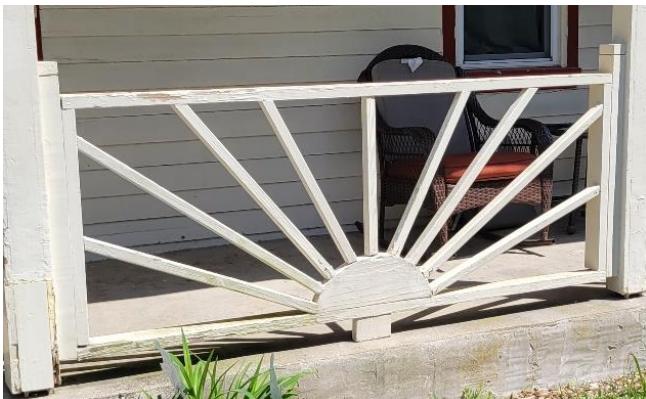
Interesting historic porch details like this starburst should be carefully maintained and preserved.

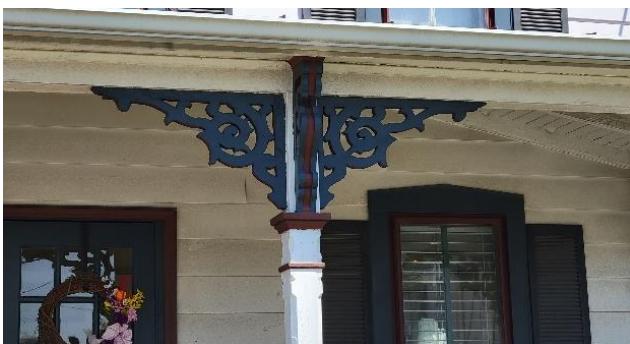
Historic porch details often disappear when a

porch is rebuilt because the various elements are no longer in production or expensive to replicate.

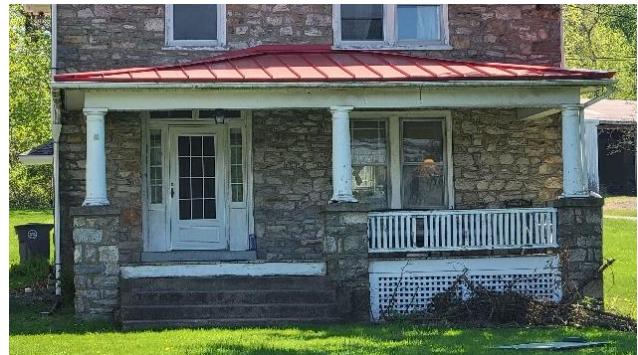
Wood porches are prominent features of many houses within the VPA. Exposed to the weather, their wood features require ongoing maintenance and occasional repair and replacement (Woodland House, 204 Byers Road, Byers Station Historic District).

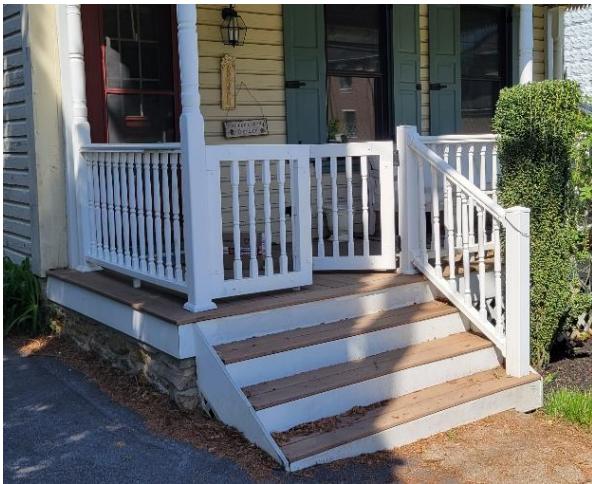
An appropriate example of a rebuilt porch.

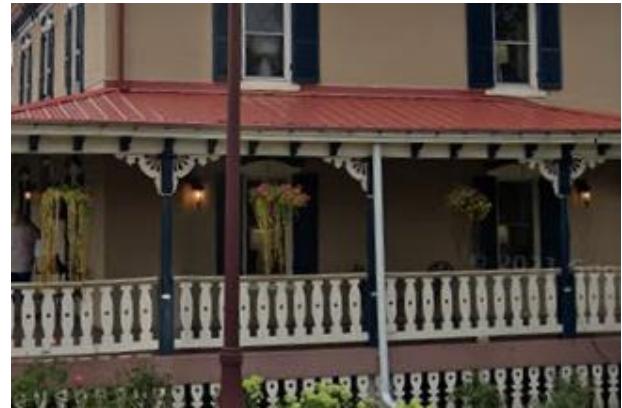
This porch has two-dimensional balusters, which were popular during the 1870s and 1880s. These balusters are character-defining elements of the porch and contribute to the building's original appearance. Also note the skirt enclosing the crawlspace beneath the porch (Sheetz House, 102 Pottstown Pike, Eagle).

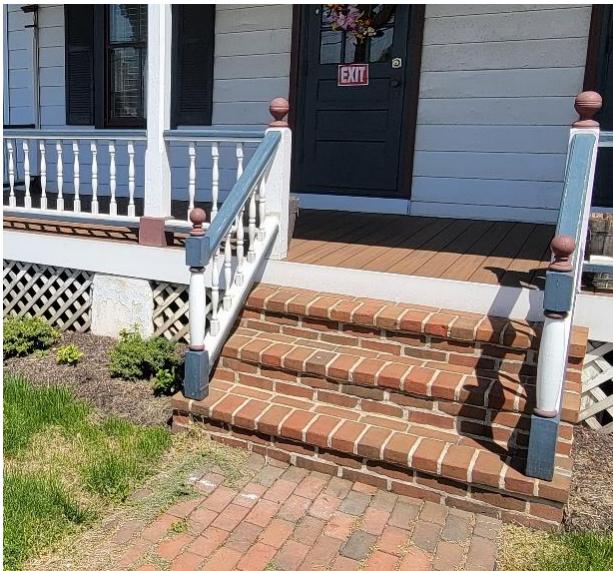
These brick steps have a railing that is consistent with the porch balustrade

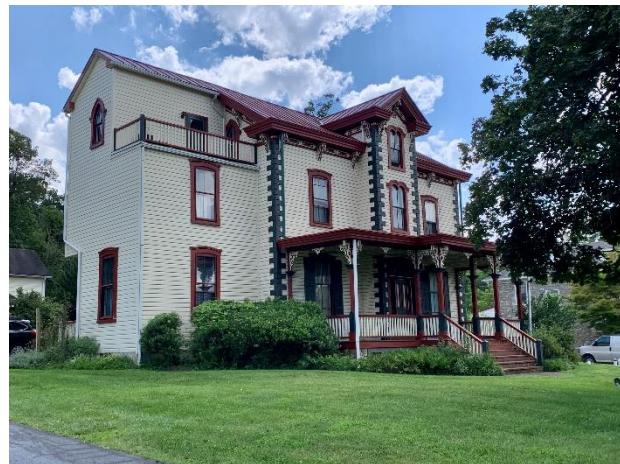
Eastern addition onto the John Todd House in Byers is somewhat compatible with the original design and in fact re-uses the original windows from the openings it covers.

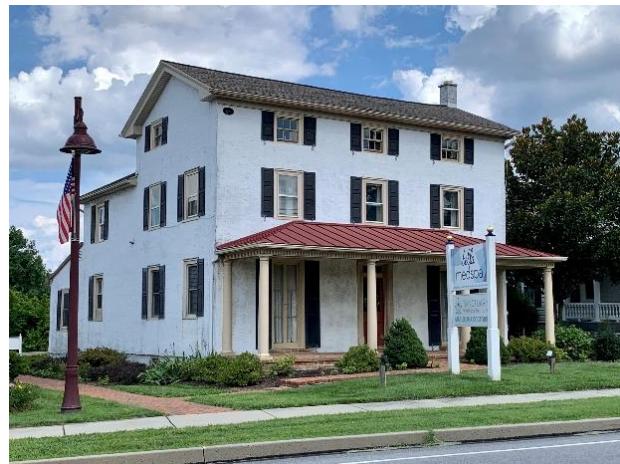
Additions onto the Butler House (122 Pottstown Pike) have enabled the building to expand while retaining the prominent original form of the main façade.

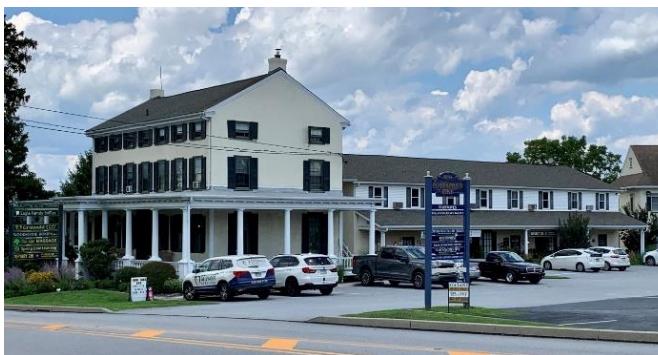
This mid-19th century historic residence (the Elizabeth Todd House on Pottstown Pike in Eagle) was converted to commercial office use with a large but compatible addition to the rear. The addition modulates reasonably in form in relation to the historic residence and does not interfere with the principle façade. It uses matching materials and colors but has creative contemporary elements.

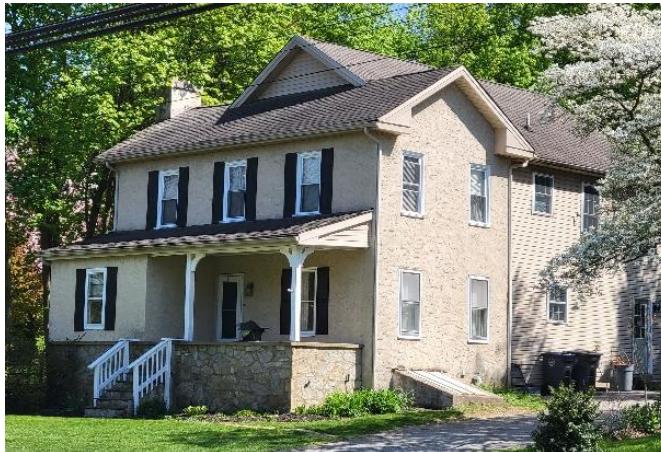
Existing additions located on the rear of the primary historic buildings within the VPA (S.W. Todd House, 236 Byers Road). The addition is in an appropriate location, although its height has altered the historic roofline and is not an appropriate treatment.

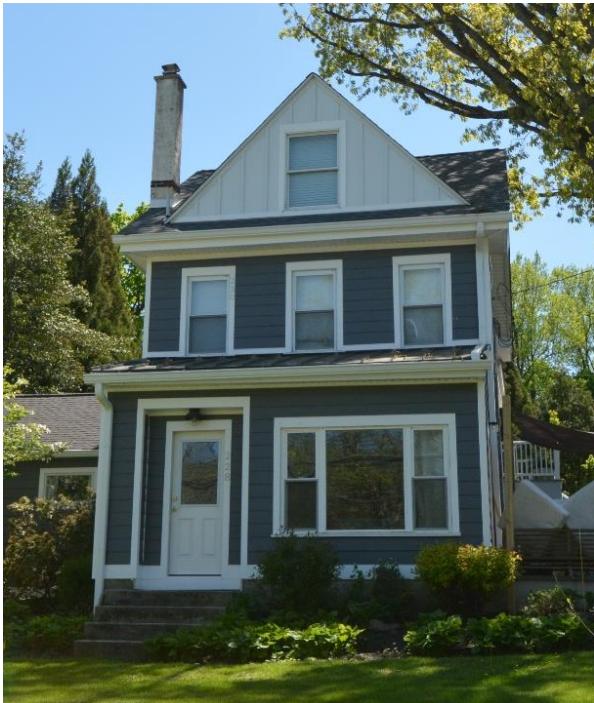
This building, which replaced an earlier house of a similar design, is generally compatible with the architectural character of the Byers Station Historic District enclosed porch notwithstanding (Joseph Grow House, 230 Byers Road).

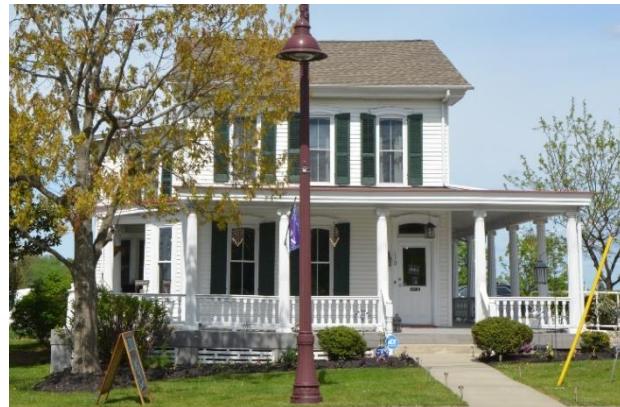
The Frank and Hannah Pearson House (114 Pottstown Pike, Eagle) is an example of historic preservation in action! The house was moved from the west side of Pottstown Pike circa 2003 and appropriately rehabilitated. It is one of several buildings forming Eagle's historic core.

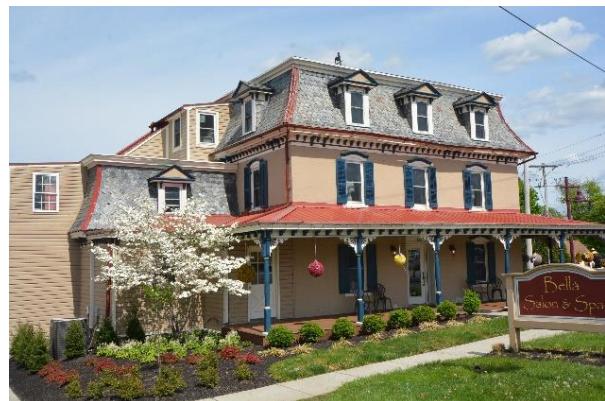
Additions on the side or rear of historic buildings may be designed to significantly expand the useable space while retaining the character of the primary structures (Sheetz House, 102 Pottstown Pike, Eagle). The additions are also set back from the primary facade of the building.

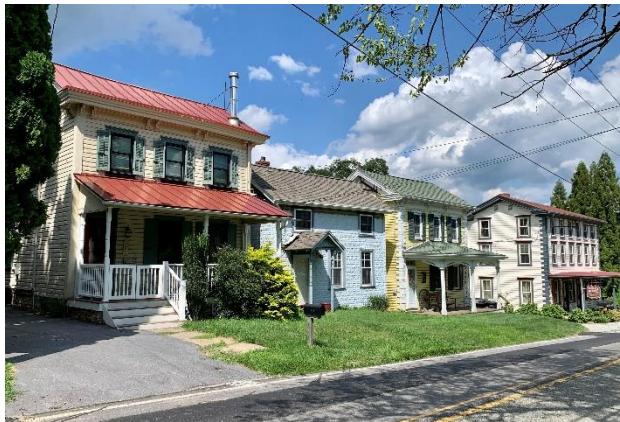
Although varying slightly in height, buildings along the north side of the road in Byers exhibit a consistent architectural rhythm.

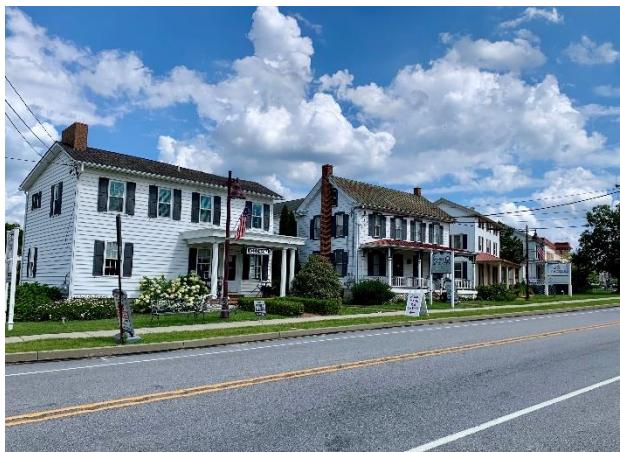
Buildings in Eagle have some variation in height but present a generally consistent pattern along Pottstown Pike.

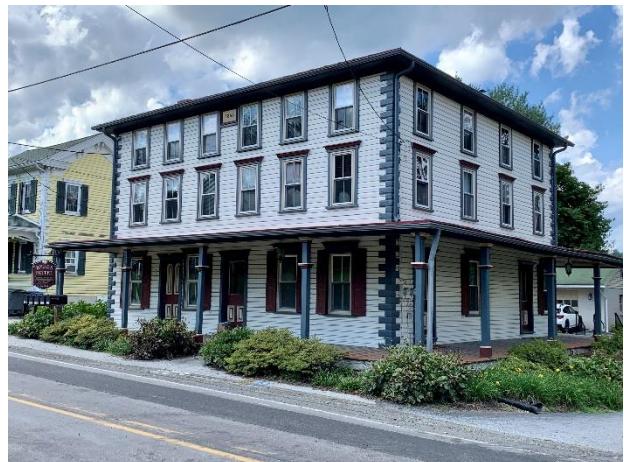
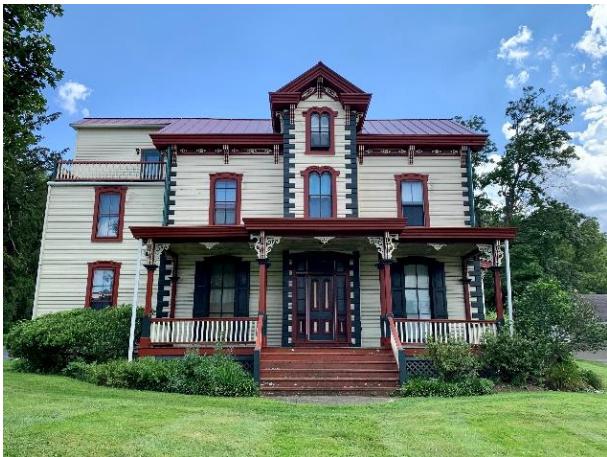
Wood is the predominant material of primary historic buildings within the VPA and is easily adaptable to the expression of additions and new construction (Byers Hotel and Todd House, Byers Station Historic District).

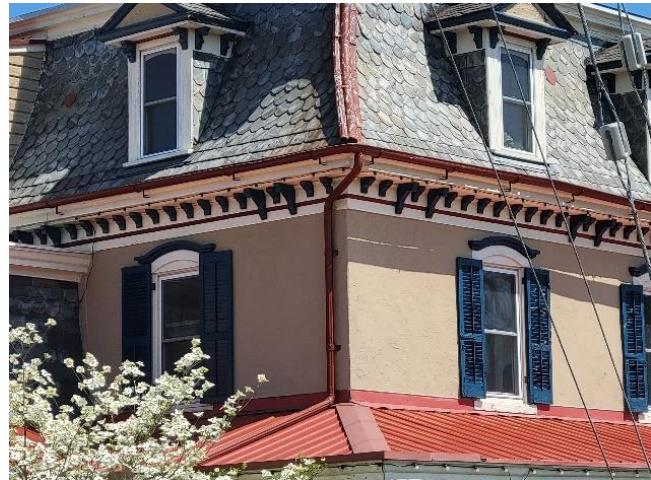
Stucco is a common exterior material of prominent historic buildings within the VPA (Sheetz House, 102 Pottstown Pike, Eagle).

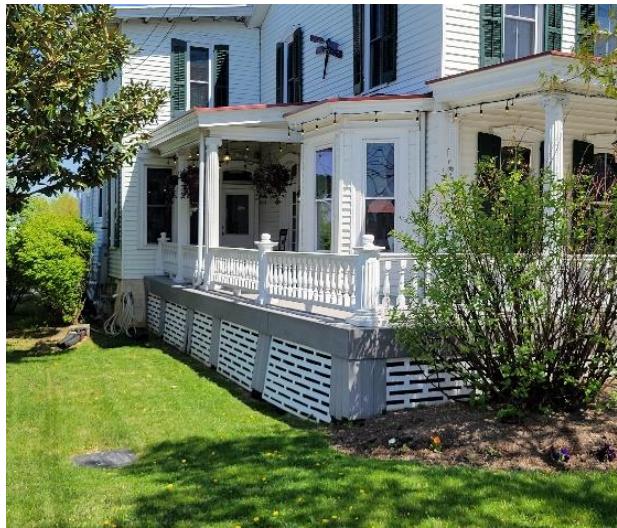
This porch was added onto this former residence to accommodate business customers. It is not of the same style as the house but has a historic design that is compatible with the residence and historic landscape (Pearson House, 114 Pottstown Pike, Eagle)

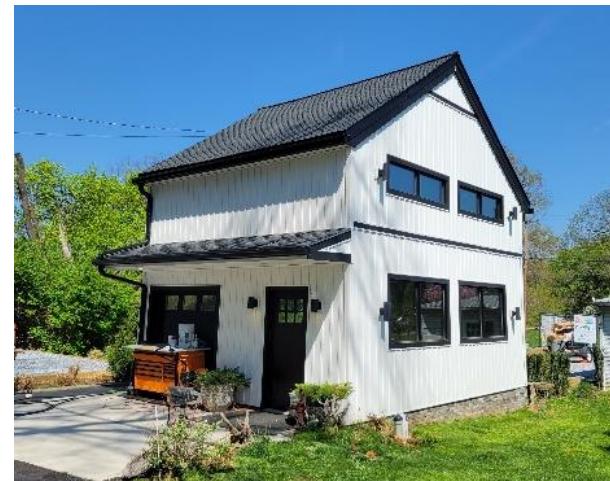
Built as a garage in Byers (115 Eagle Farms Road, Byers Station Historic District), this outbuilding is appropriately scaled and designed to be compatible with the historic district.

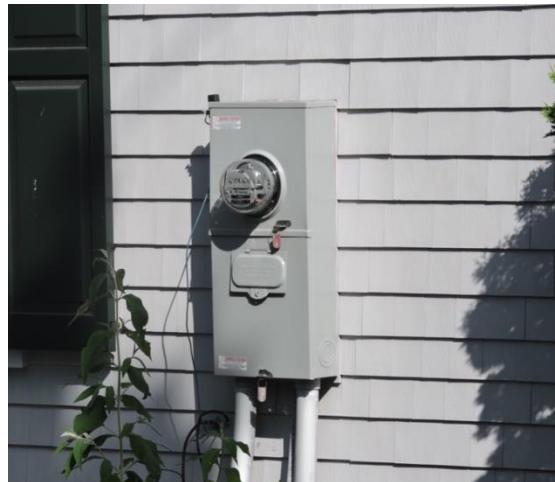
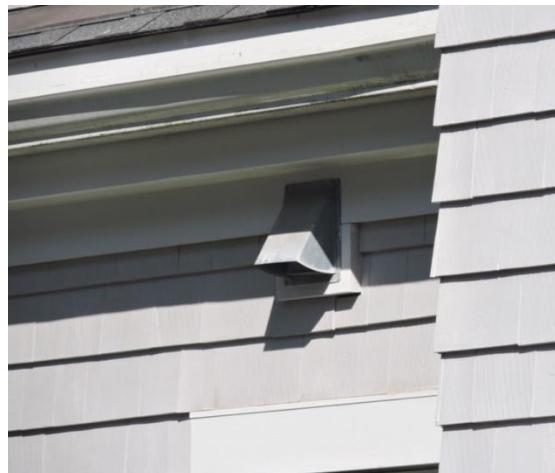
Mechanical installations such as electrical boxes and dryer vents should be located on side and rear facades and be minimally visible from the street.

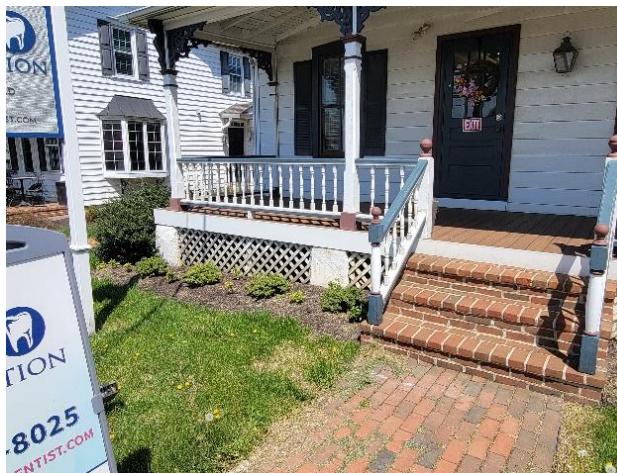
*Contemporary brick pavers within the VPA
(Isaac D. Frame House, 124 Pottstown Pike,
Eagle).*

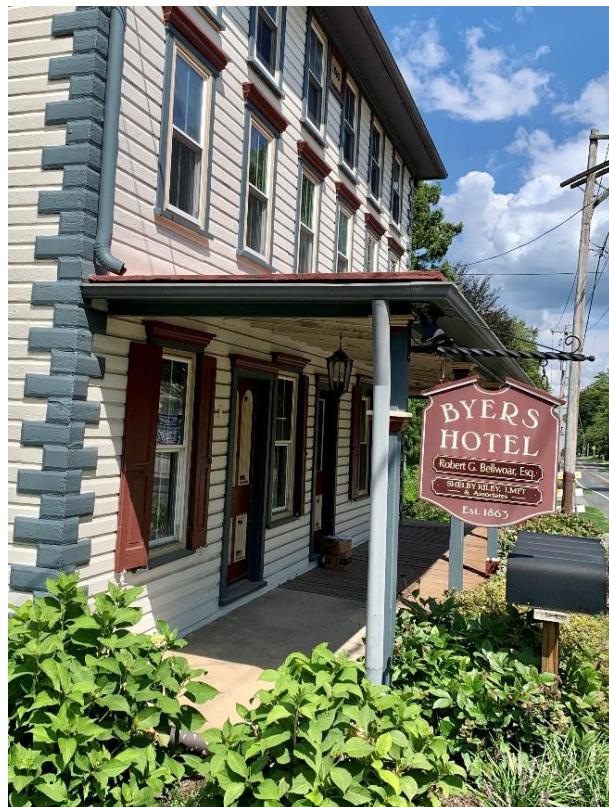
This projecting sign on the former Byers Hotel in the Byers Station Historic District is appropriate in size, design, location and materials. It is appropriate for the building type, the dense layout of Byers, and the proximity to Byers Road.

- a. **Projecting Signs:** these signs are hung perpendicular to the building. A decorative bracket attached to the building usually supports the sign. The sign in front of the Byers Hotel is an example. This type of sign is a recommended type.

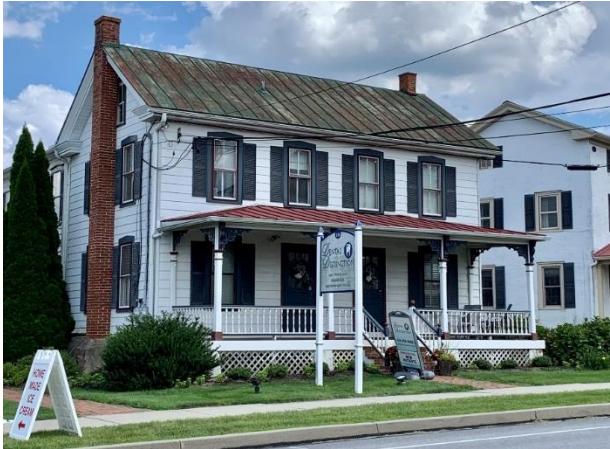
Commercial signs in Eagle. The permanent sign is appropriately scaled for the village and the building; similar signs are found throughout the village along Pottstown Pike. The smaller temporary signs are not recommended. (Isaac D. Frame House, 124 Pottstown Pike).

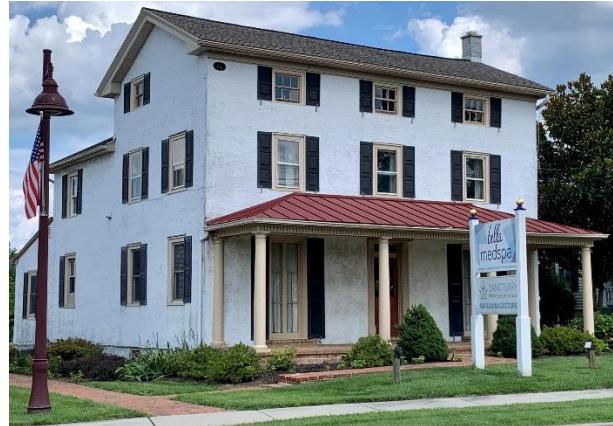
Appropriately sized sign in Eagle (Butler House, 122 Pottstown Pike)

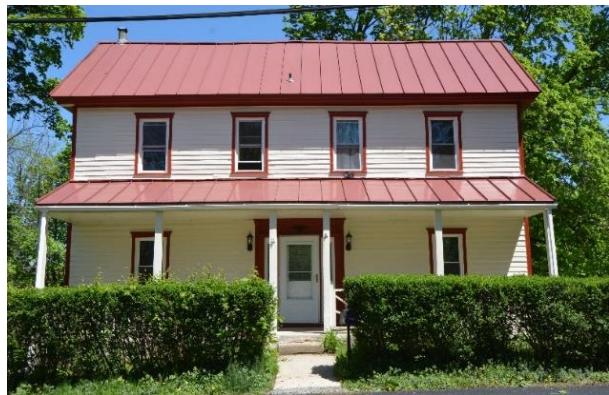
Wood is the predominant material used in the construction of residences in the VPA (Joseph Butler House, 119 Eagle Farms Road).

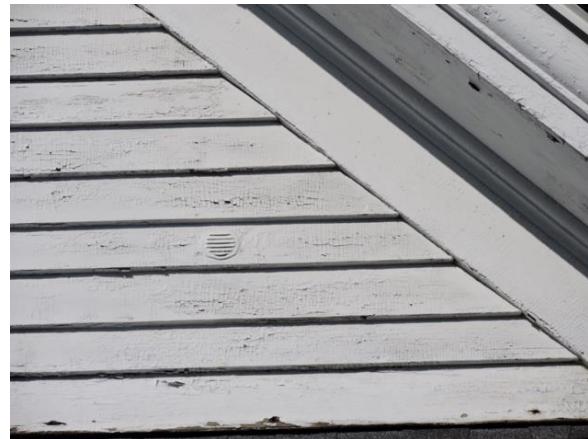
This siding shows indication of peeling paint. The small metal vent allows interior moisture to escape; retained moisture can eventually lead to interior rot and peeling paint, which can cause the wood siding to also rot.

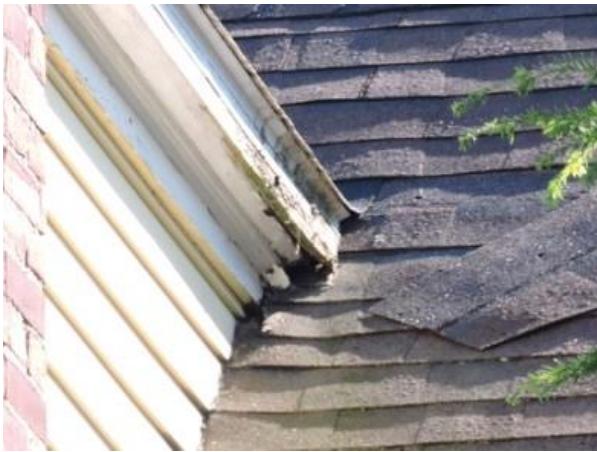
The fascia and soffit boards of this cornice have rot due to moisture drawn from contact with the roofing. The resulting hole in the soffit on the underside of the cornice could serve as an entranceway for squirrels, causing additional damage to the building.

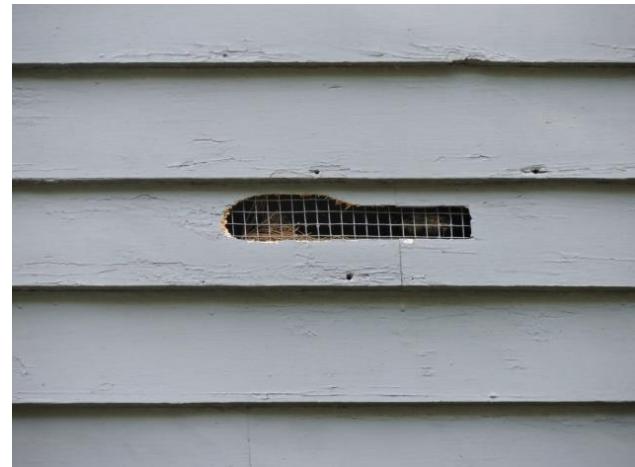
This hole, now sealed with mesh screening, in historic wood siding may have been created by woodpeckers and perhaps widened by chewing animals; nesting material can be seen inside.

- h. **Bird and Squirrel Holes:** Once identified, birds and squirrels should be chased out and the holes repaired. Extensive damage and sanitary problems can be caused by the animals inside the structure, and the holes allow moisture inside the walls causing rot.

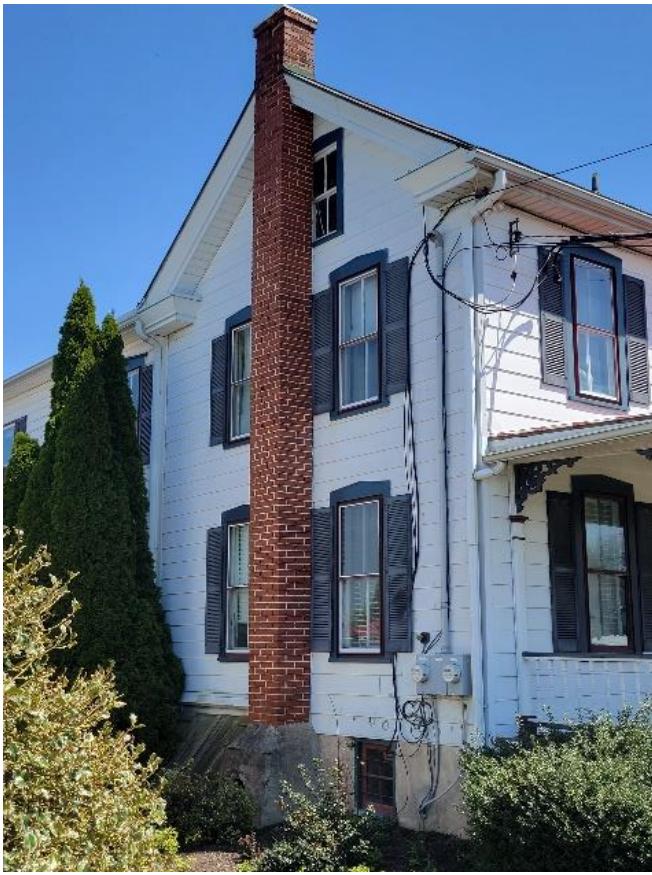
House in Eagle with a brick chimney (Isaac D. Frame House, 124 Pottstown Pike). The chimney was probably added in the twentieth century for an oil furnace.

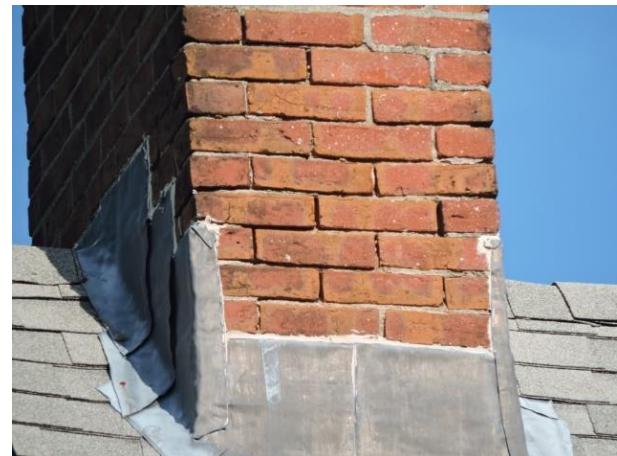
Within the VPA, brick is most often found as the construction material for chimneys, rather than walls. Difficult to access, this brick chimney has open joints which will absorb water.

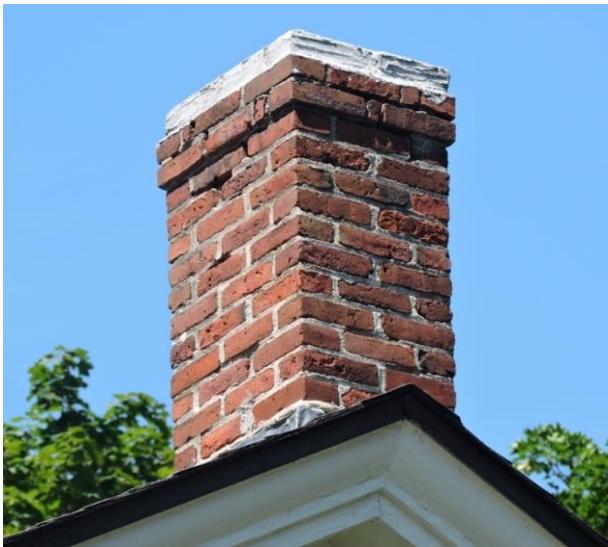
The bricks in this chimney show their age – some are chipped and slightly spalled. They need not be repaired or replaced if they do not threaten the masonry as a whole.

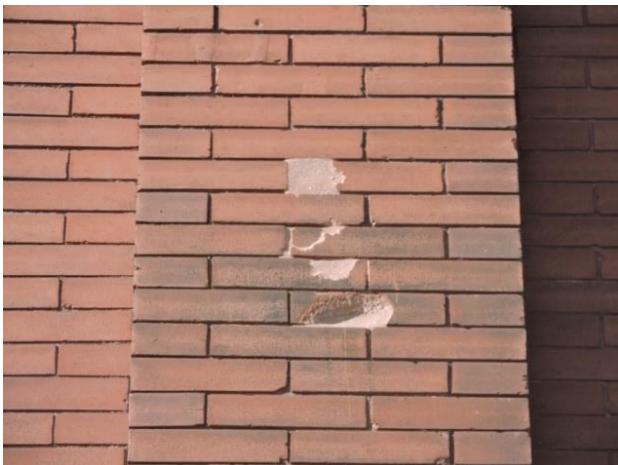
The surfaces of these bricks have spalled, but the joints appear to be in good condition.

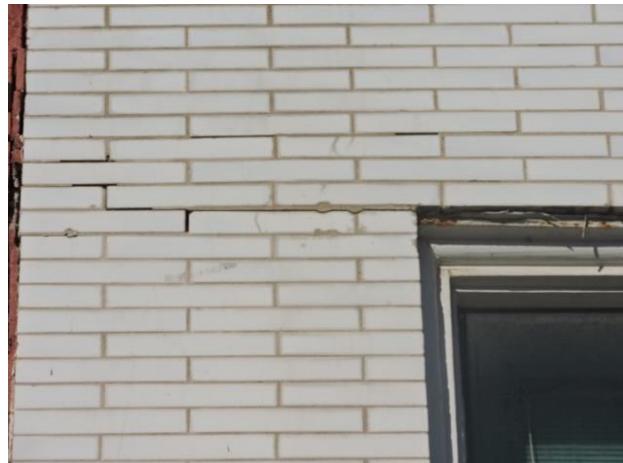
Jacking of a steel lintel at the window to the right has caused cracking of the brick masonry at left.
