VILLAGE DESIGN GUIDELINES

VILLAGE PLANNING AREA, INCLUDING VILLAGES OF EAGLE & BYERS Upper Uwchlan Township, Chester County, Pennsylvania

**Prepared by
Richard Grubb & Associates, Inc.
The Brandywine Conservancy, Inc.**

Draft: June 21, 2024

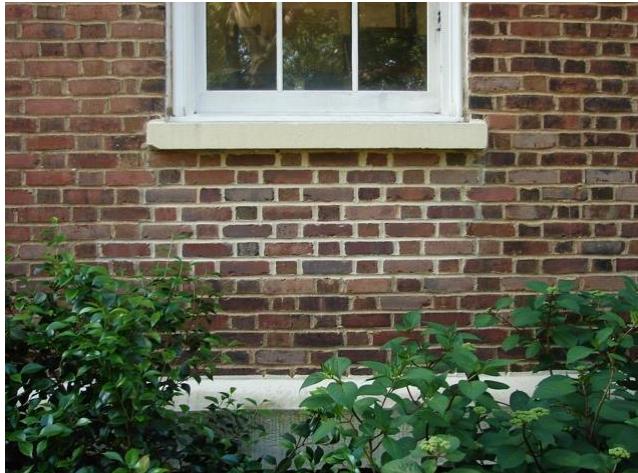
The repointing below the window in this historic wall does not match the color, texture, or tooling of the historic mortar to the right and left.

- a. **Repointing:** Repoint open or unsound mortar joints. Match historic mortar joints in color, texture, strength, joint size, and tooling. Work to achieve visual continuity between surviving historic material and new patches. Do not repoint sound historic mortar joints.
- b. **Unsound Mortar:** Remove unsound mortar to a depth of two-and-one-half times the width of the joint or to sound mortar, whichever is greater. Remove unsound mortar joints with hand tools that are narrower than the mortar joint. Do not use power tools, because they can scar adjacent masonry.
- c. **Saw Cut:** Under special circumstances and careful supervision, a thin saw cut may be run down the center of a horizontal joint with the remainder being removed by hand. However, masonry saws should never be used on vertical joints.

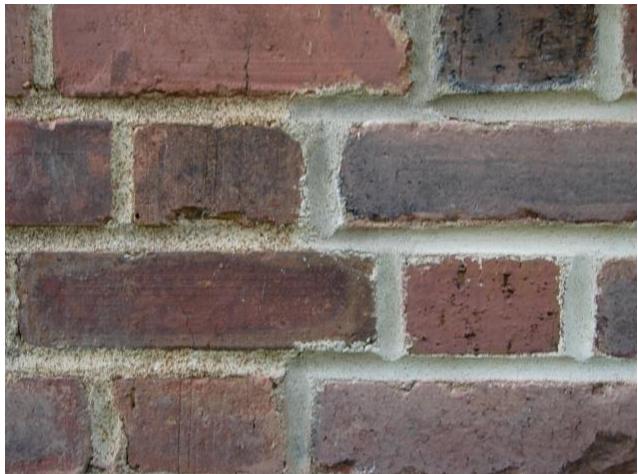
Detail of repointed joints showing modern grey mortar to the right that does not match the rich brown color and texture of the historic sand mortar to the left.

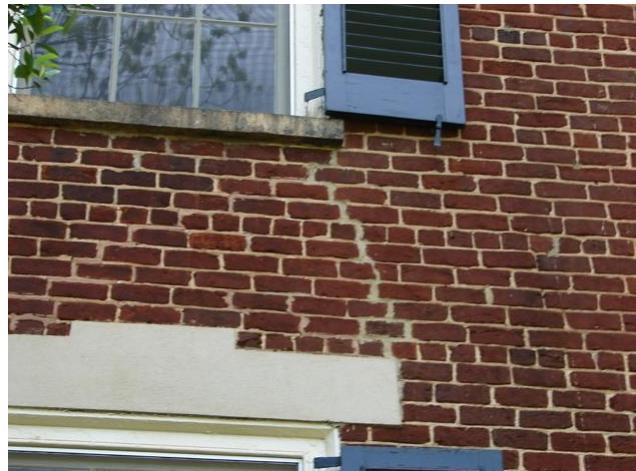
Repair of a structural crack caused by building settlement between the lintel of the window below and the sill of the window above.

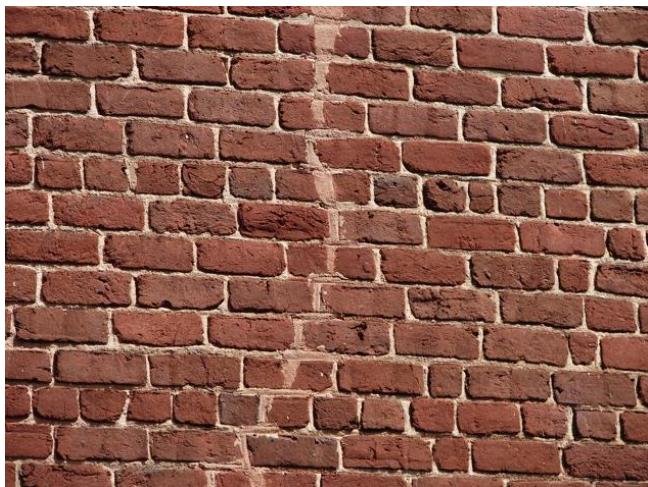
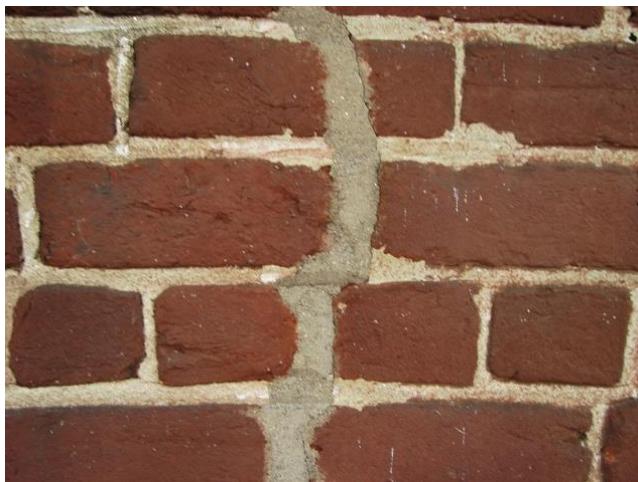
The crack repairs in the two photos above use mortar that differs in color and texture, not matching adjacent historic mortar. Additionally, cracked brick units were not removed and replaced before their cracks were repointed. Though not preferred, this treatment may be appropriate when matching bricks cannot be obtained, such as in the extremely old wall at top; but in general is not recommended.

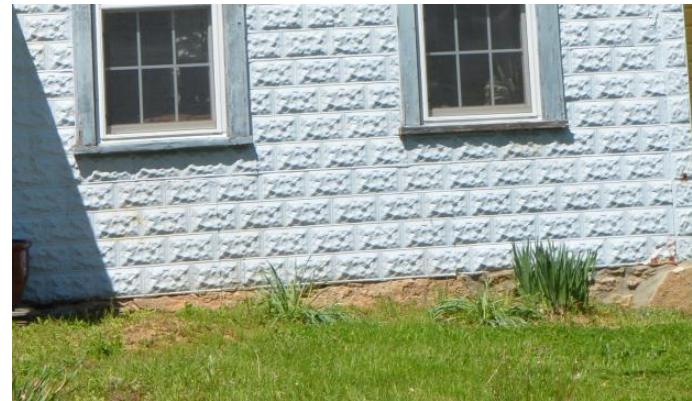
Stone foundation of a wood framed vernacular building (219 Byers Road, Byers Station Historic District). Note: the building is clad in pressed tin.

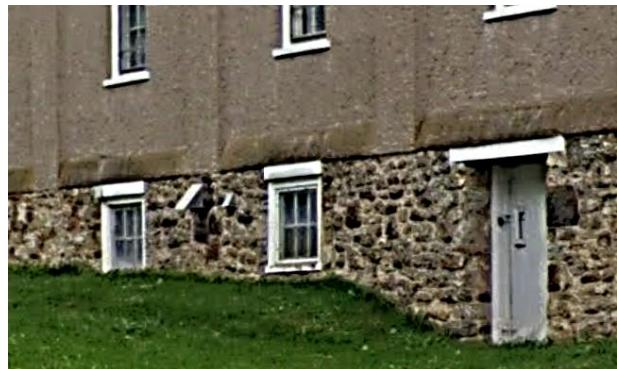
A stone foundation wall within the VPA (218 Byers Road, Byers Station Historic District).

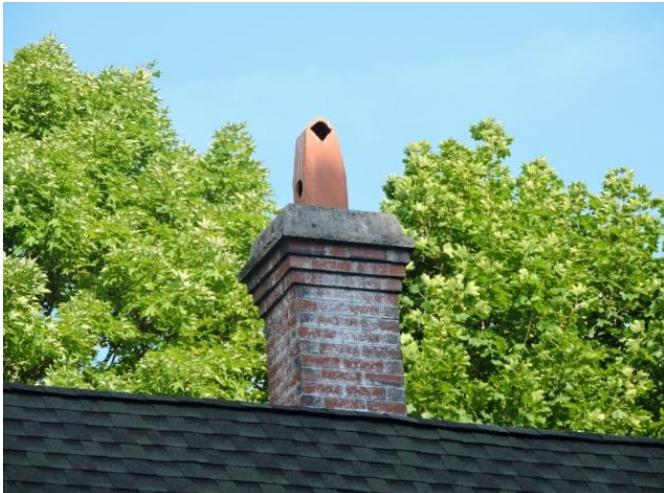
This chimney has a custom stone cap with a terra cotta flue cap.

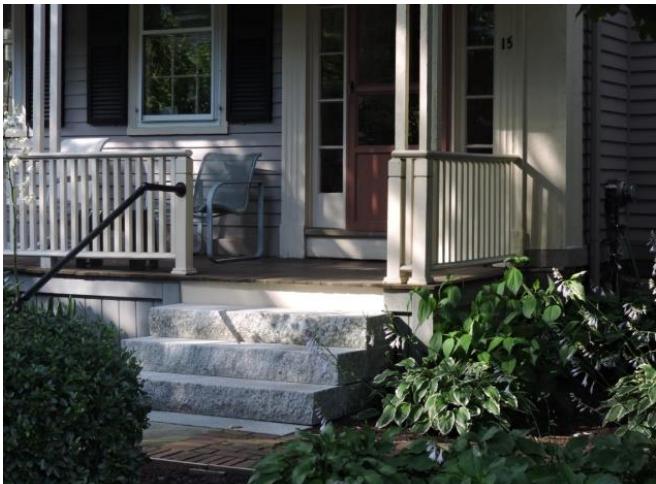
Stone or masonry exterior steps are compatible with the character of the VPA.

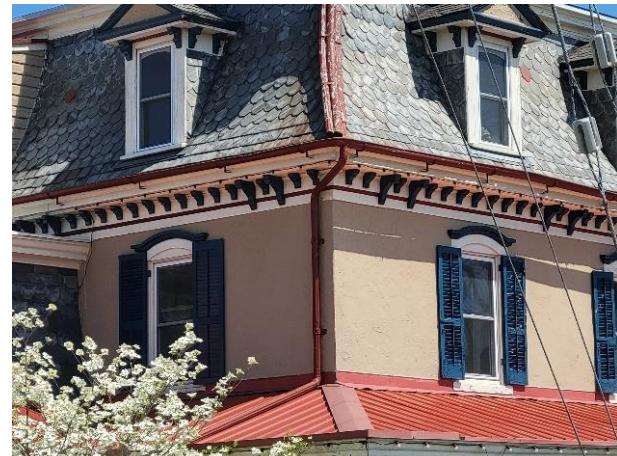
Details of stucco walls (Sheetz House, 102 Pottstown Pike, Eagle).

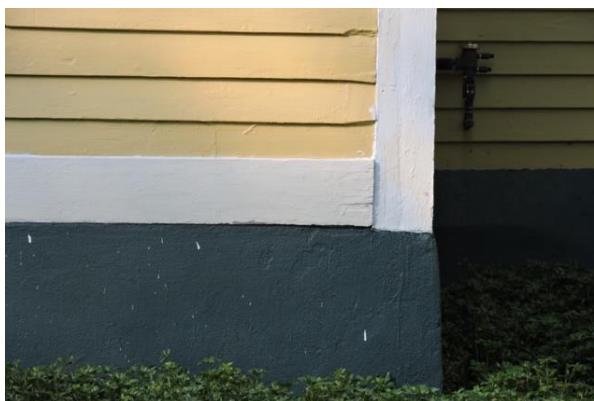
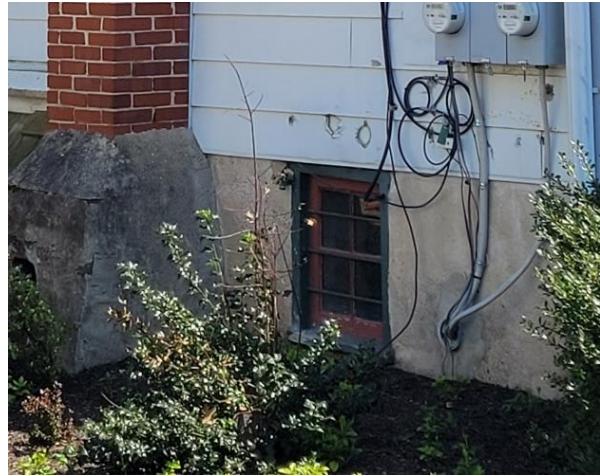
Stucco has been used as a protective coating over vulnerable masonry foundation walls

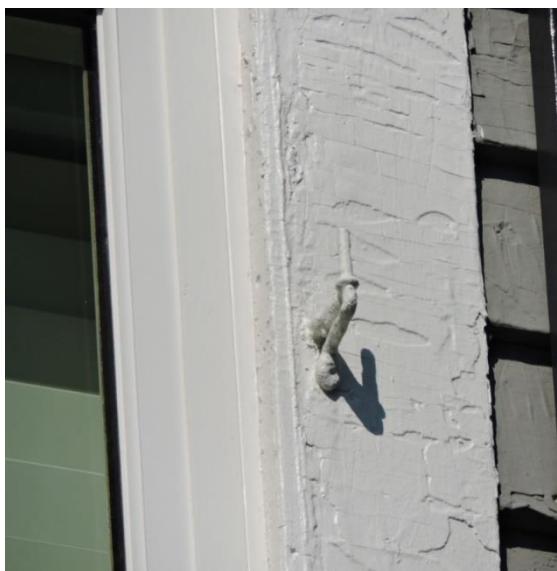
Vestigial historic metal features such as this pintle from a late nineteenth century shutter hinge point to the building's appearance in earlier years.

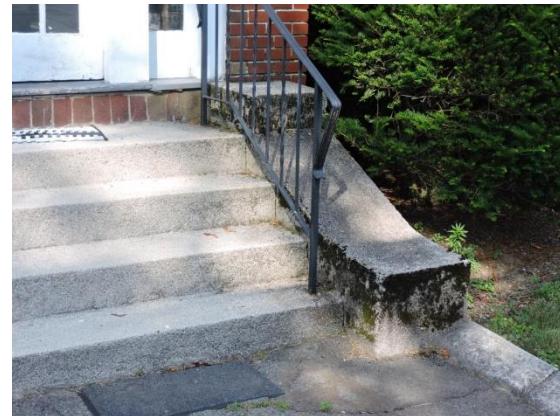
When installing metal handrails within the VPA, be mindful that their posts are susceptible to deterioration where they anchor into concrete or masonry. This can in-turn damage the surrounding concrete or masonry.

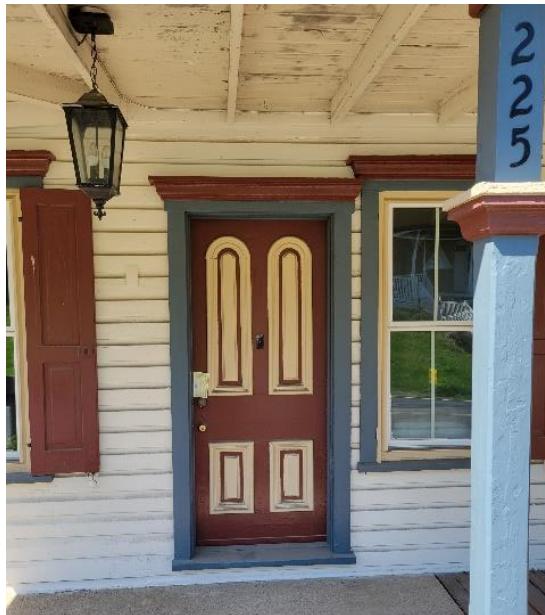
Decorative metal features such as this light and house numbers are generally modern installations within the VPA (Byers Hotel, Byers Station Historic District).

h. **New Metal Features:** Where new or replacement metal features are required, their design should be sympathetic to the historic character of the building. Most modern stock handrails, for instance, are not appropriate for historic buildings. Sympathetic modern profiles should be found. Usually, simplicity is preferred over new metal features that are highly decorative, especially for vernacular residential buildings.

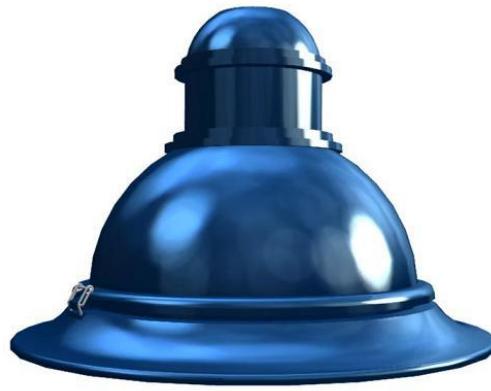
Note: The following is the street lighting that currently exists in Eagle. If this specific make and model is not available in the future, the design and style should be replicated via a Township-approved equivalent. The lighting type used in Eagle may not be appropriate for use in Byers.

EPA: 1.42 sq ft / weight: 42 lb (19.1 kg)
